Report on
Urban Capability Study

Proposed Subdivision
Neighbourhoods 3 - 5, Googong

Prepared for
Spacelab Studio Pty Ltd

Project 46285.44
June 2019

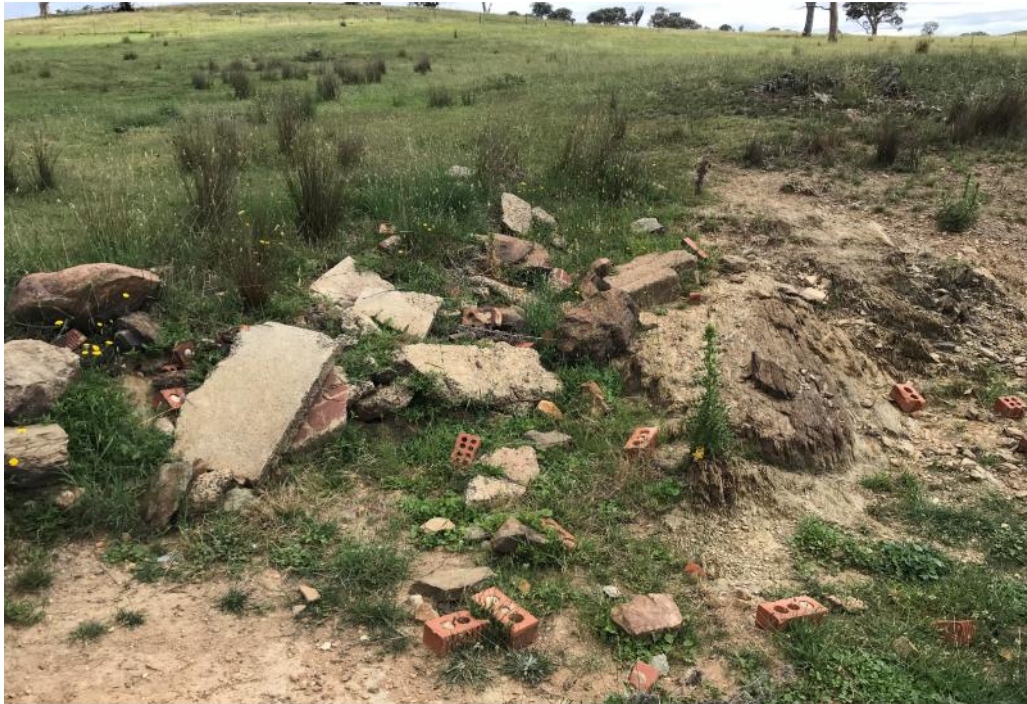
Photo A13 – Building rubble and outcropping rock adjacent to dam. Refer Drawing 2 for locality and direction

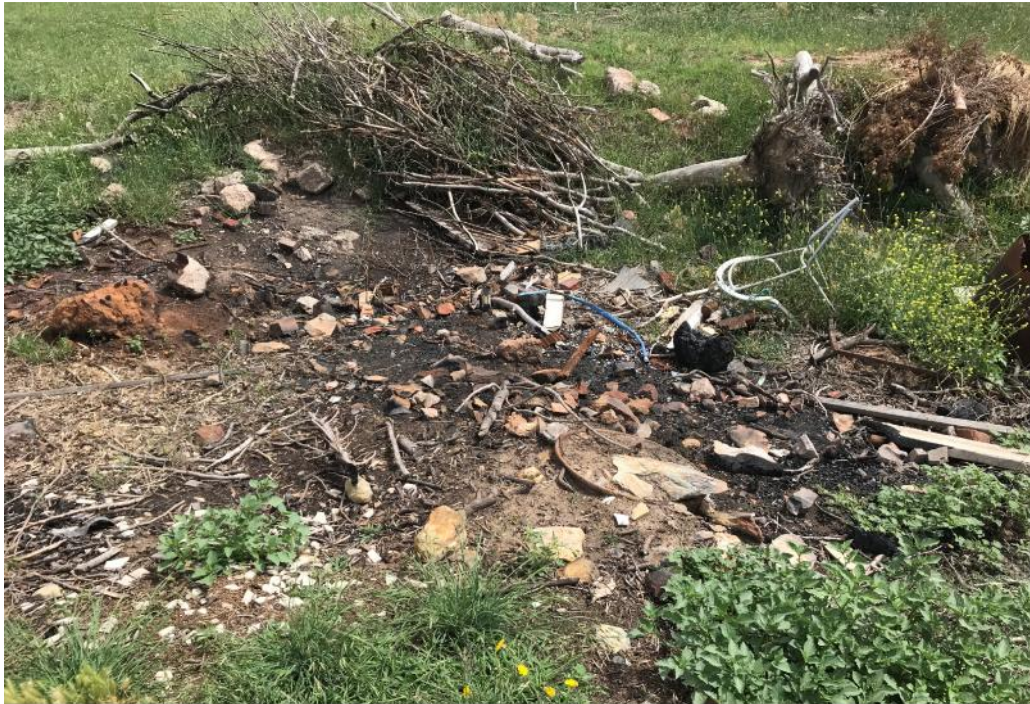
Photo A15 – Burn pit with building rubble and old drum. Refer Drawing 2 for locality and direction

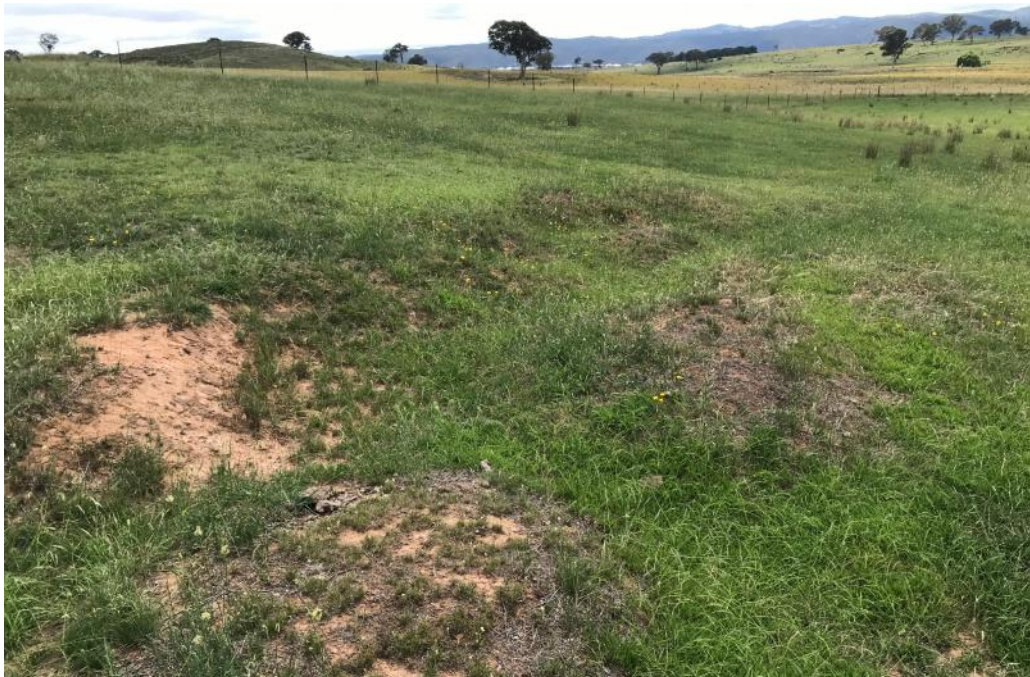
Photo A16 – Minor erosion. Refer Drawing 2 for locality and direction

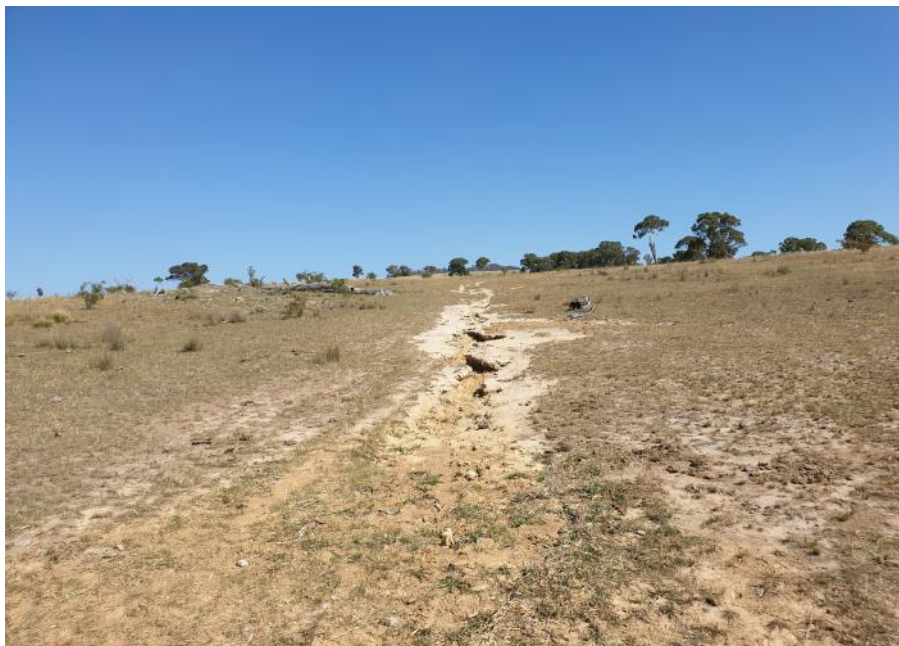
Photo A24 – Erosion. Refer Drawing 2 for locality and direction

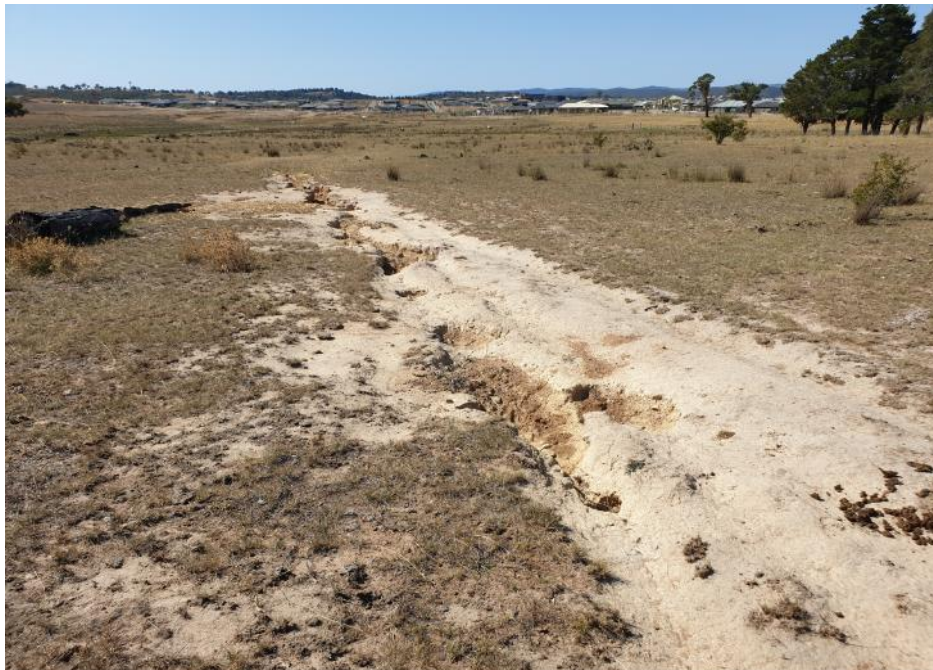
Photo A25 – Erosion. Refer Drawing 2 for locality and direction

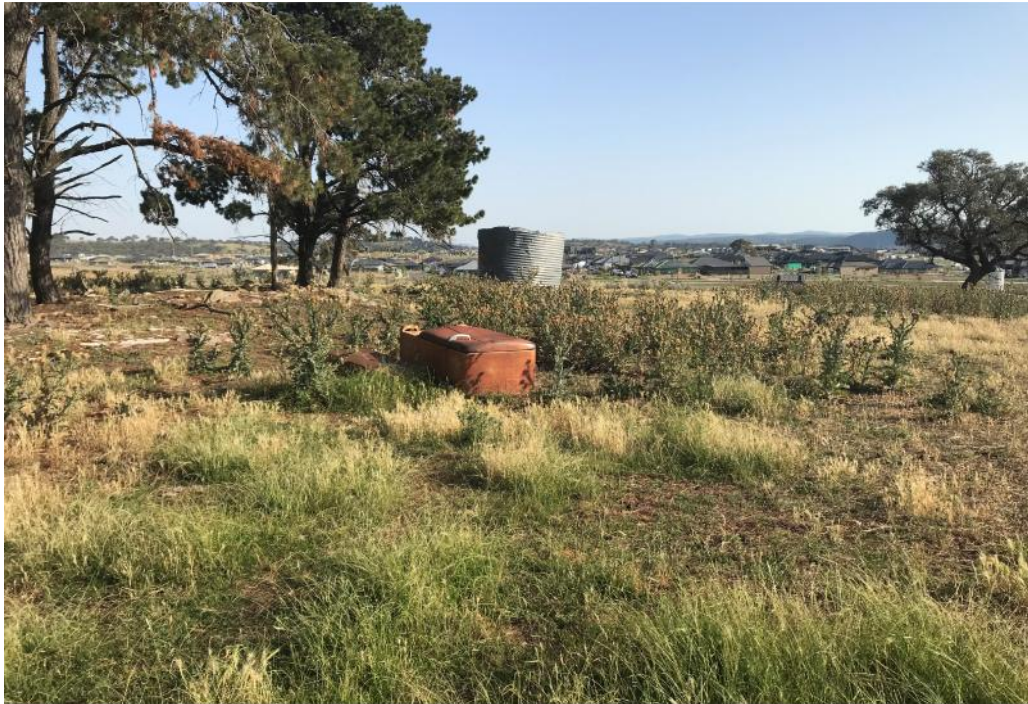
Photo A29 – Water tank and discarded fridge. Refer Drawing 2 for locality and direction

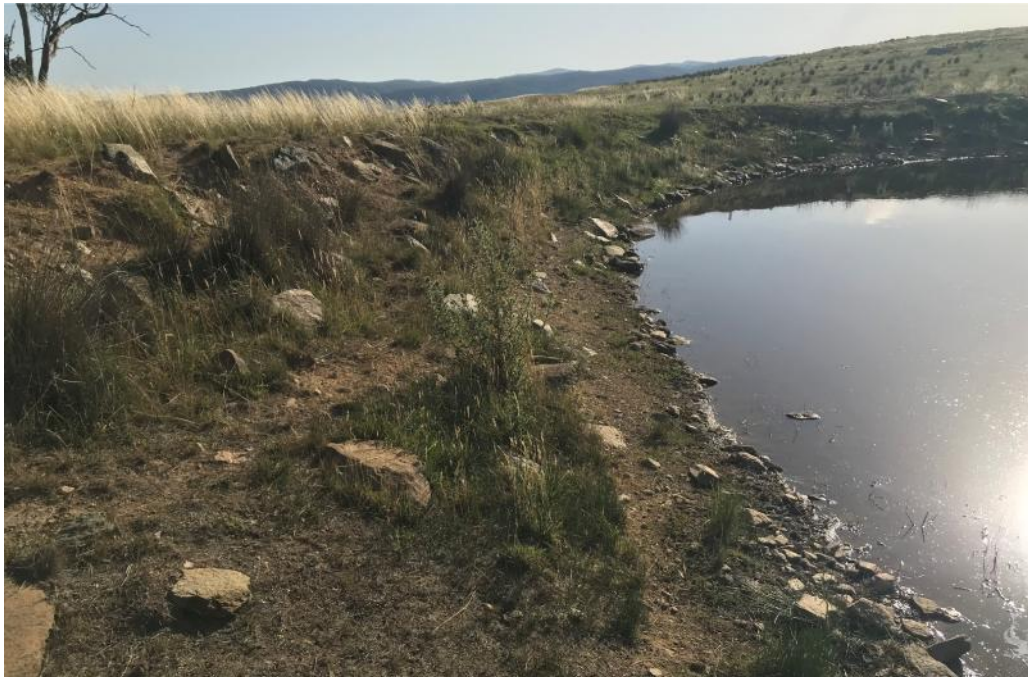
Photo A30 – Boulders in dam embankment filling. Refer Drawing 2 for locality and direction

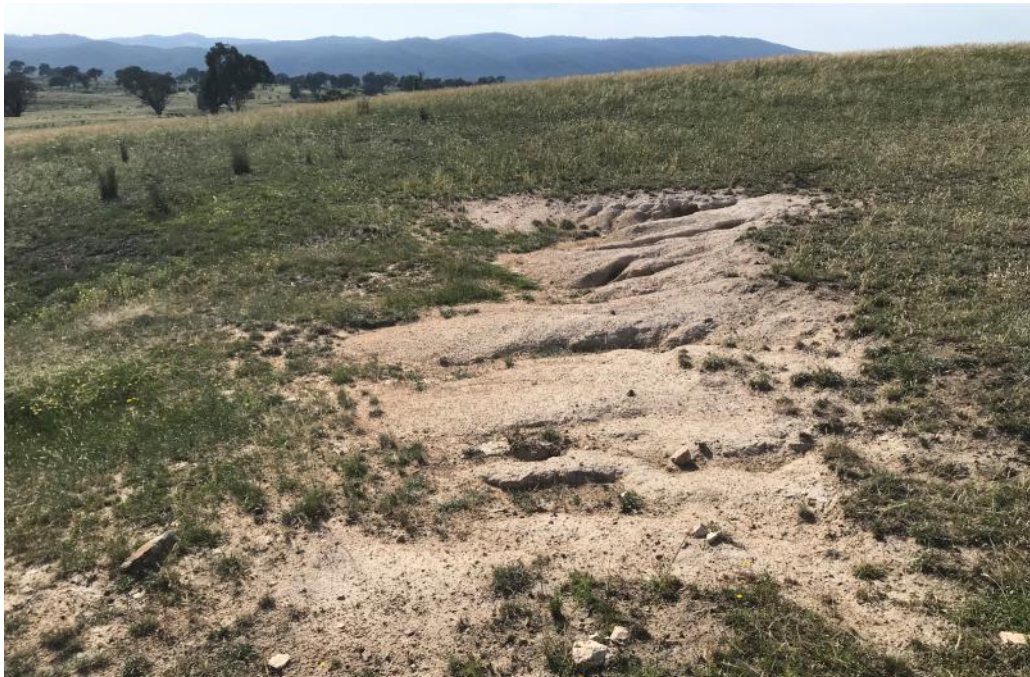
Photo A34 – Erosion on hill side. Refer Drawing 2 for locality and direction

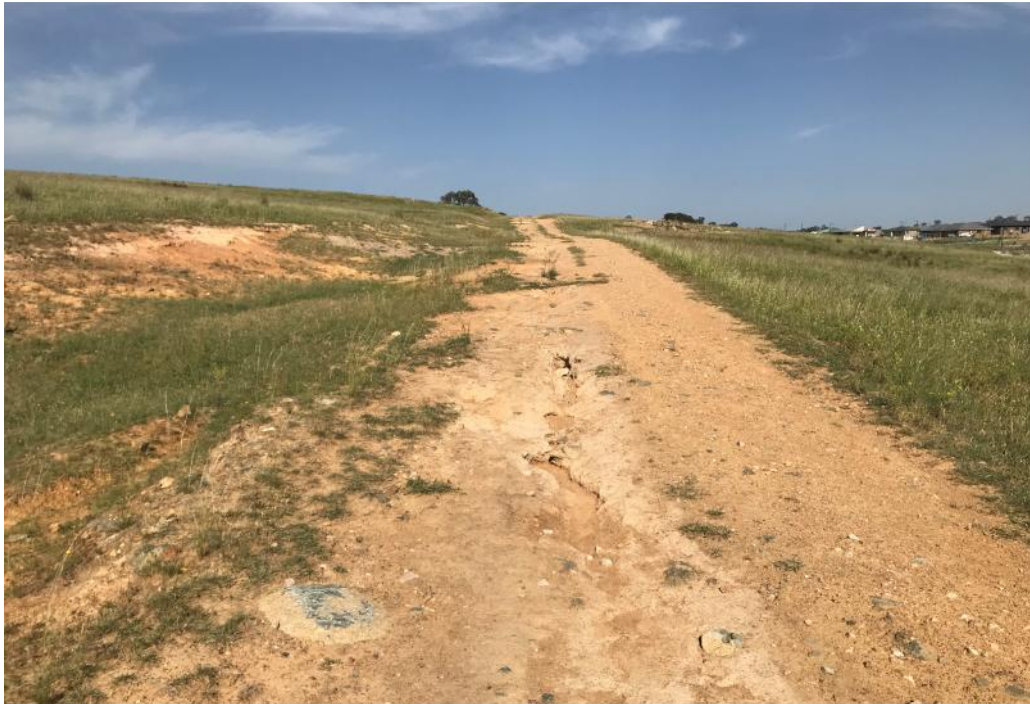
Photo A37 – Erosion in access track and hill side. Refer Drawing 2 for locality and direction

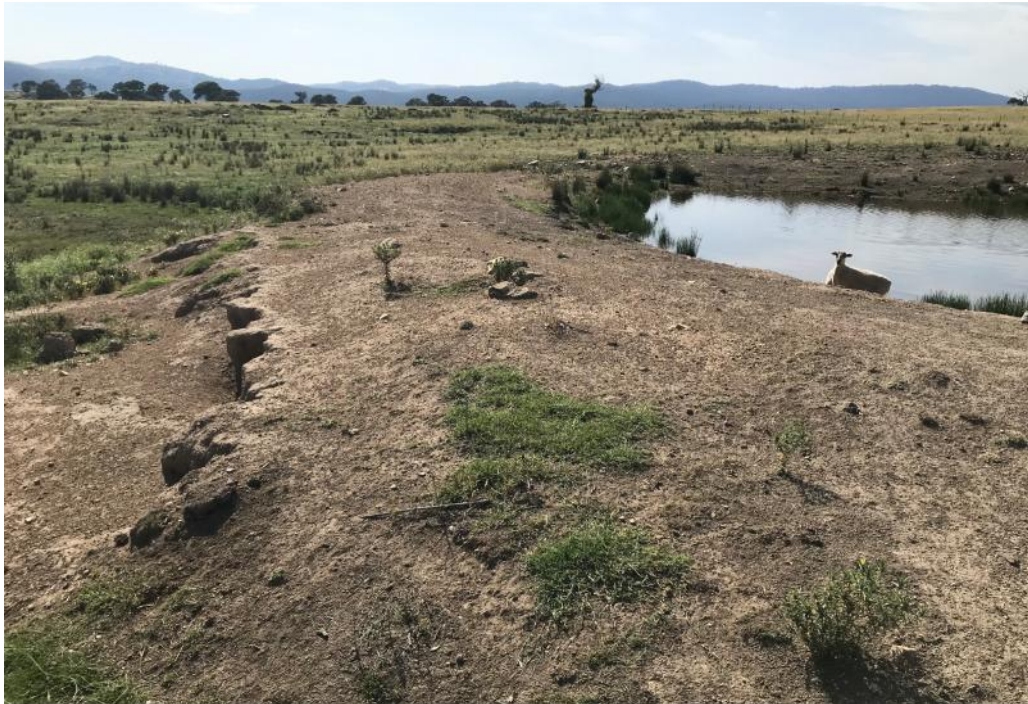
Photo A39 – Erosion in dam wall. Refer Drawing 2 for locality and direction

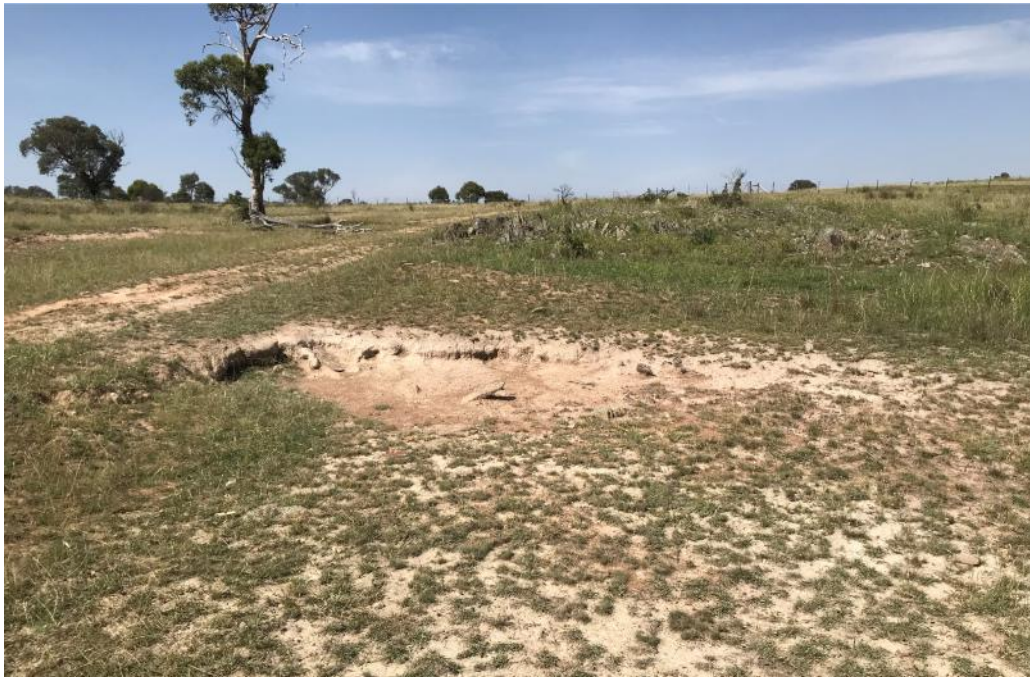
Photo A44 – Erosion. Refer Drawing 2 for locality and direction

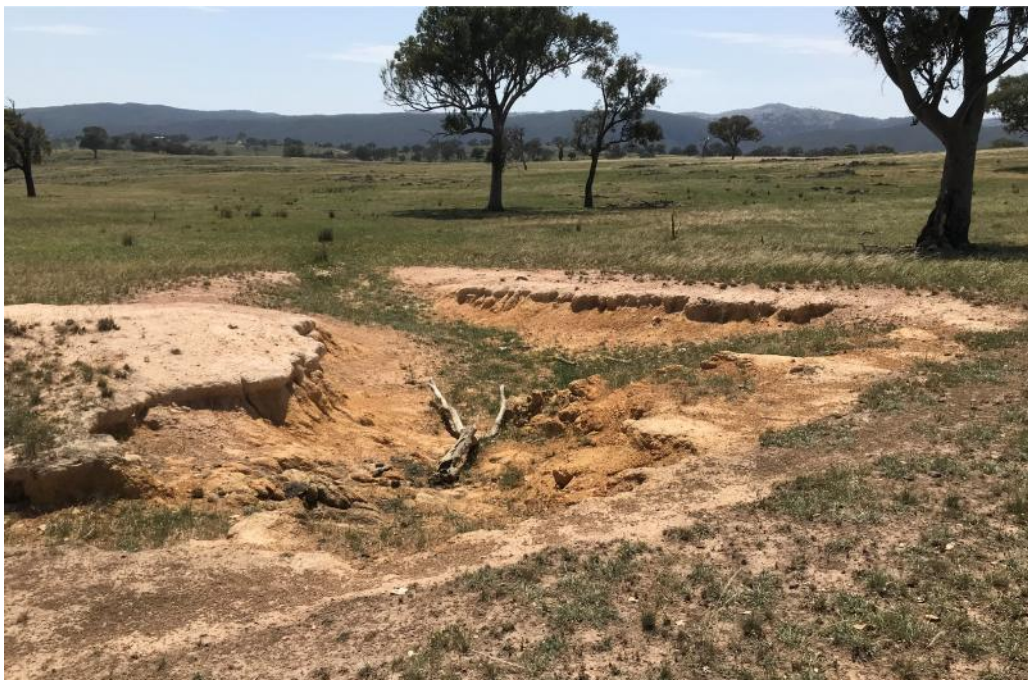
Photo A48 – Erosion. Refer Drawing 2 for locality and direction

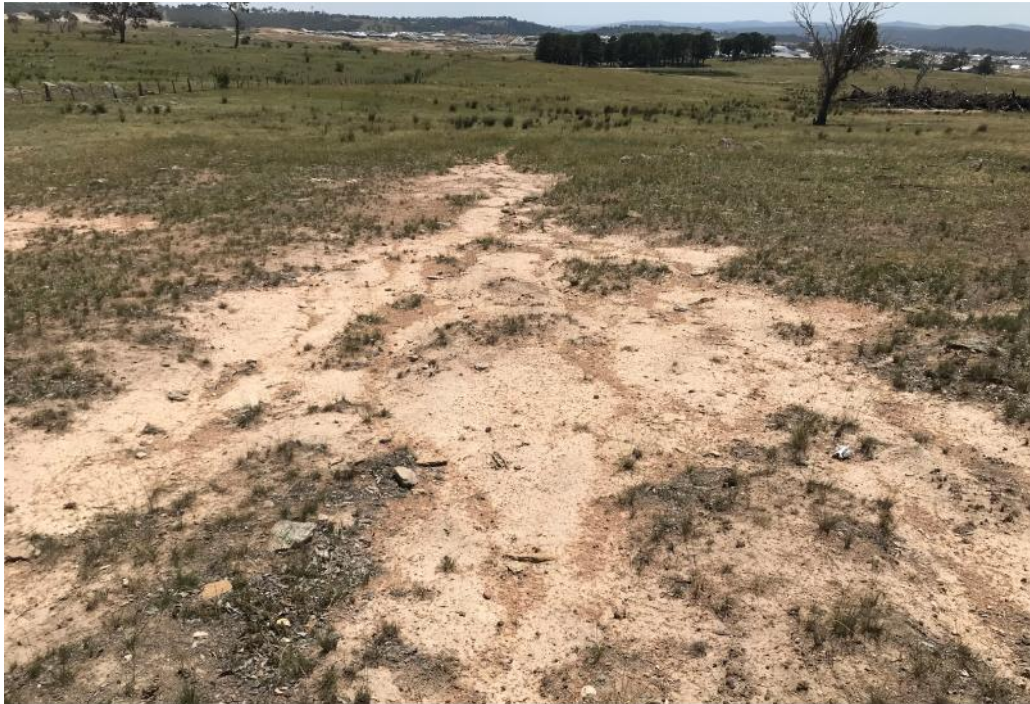
Photo A51 – Erosion. Refer Drawing 2 for locality and direction
